2018-01-1240 Published 03 Apr 2018

# Hydrogen Embrittlement Susceptibility of Case Hardened Steel Fasteners

John S. Medcalf Peak Innovations Engineering

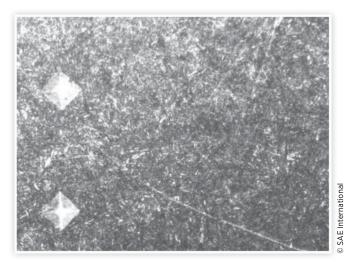
**FIGURE 10** Near-surface microstructure showing predominantly tempered martensite at 500X magnification

An evaluation of the microstructure revealed predominantly tempered martensite in every fastener examined as expected. Sample images of both core and surface microstructures are seen in Figures 9 and 10. While some inclusions were found to be present, they were not extensive and were not evaluated further. The effect of the surface hardening process is evidenced in the change in appearance of the microstructure near the surface compared to the core. While still showing a structure of tempered martensite, the grain size appears smaller, and the additional carbides result in a much darker appearance from the increased carbon content during the carburization process.

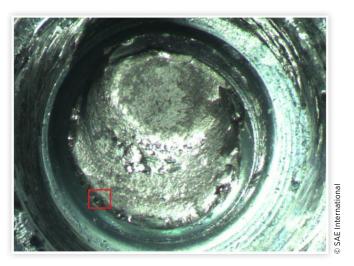
**FIGURE 11** Torsion failure fracture surface - area of note magnified in Figure 12

in <u>Figures 11</u> and <u>12</u>. The fracture surface mainly showed evidence of ductile failure, except for the high hardness surface region, which showed evidence of brittle intergranular fracture. This evidence can be seen circled in <u>Figure 12</u>.

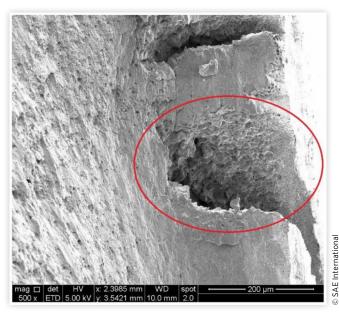
**FIGURE 12** Torsion failure fracture surface at case hardened area 500X magnification

Another feature observed during SEM analysis was the brittle intergranular fracture near the surface of a sample that was failed in torsion for establishing an assembly torque. Because it was not a delayed failure, the brittle fracture could not have been a result of hydrogen embrittlement. This feature is of interest, as during tightening the case hardened fasteners exhibited audible "popping" sounds as if they were beginning to crack well below the ultimate failure torque. If something in the nature of the high hardness outer case causes brittle cracks to form even during normal tightening, it may have the effect of increasing the susceptibility to EHE. This is another aspect that would be beneficial to evaluate further in future studies.

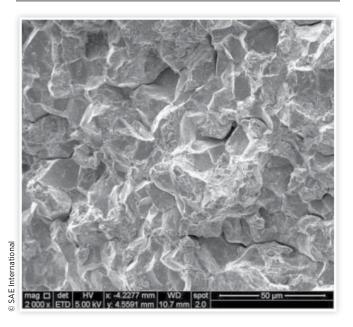
**FIGURE 14** Batch 24 sample showing intergranular fracture 2000X magnification

The next fastener examined was also from batch 24, but failed in sustained load embrittlement testing in a corrosive environment. Its fracture surface showed predominantly brittle intergranular fracture as seen in <u>Figures 13</u> and <u>14</u>. However, the lower hardness core also exhibited some ductile failure regions.

high magnification via SEM. While some parts that failed embrittlement testing exhibited predominantly brittle intergranular fracture, some also showed areas of ductile failure. This is an indication that the entire material cross section would not have to be of a susceptible condition, but once the net section area is reduced by crack propagation, the fastener can fail due to excessive stress. This further emphasizes the importance of understanding the effects of case hardening and how much of the material may see an elevated hardness as a result.

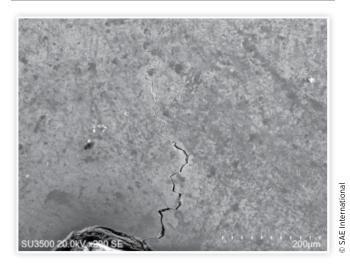
**FIGURE 18** Crack in batch 17 sample that passed embrittlement testing 200X magnification

More unexpected features were the cracks observed in a sample from Batch 17 that did not fail embrittlement testing. Figures 17 through 20 show multiple cracks extending a significant depth into the fastener core and a crack on the flank of a thread, which would not have been expected to be an area of highest stress concentration. In all cases, the cracks appear to be brittle intergranular in nature, progressing from the high hardness surface and ending in the lower hardness core.
