# Hydrogen Embrittlement Susceptibility of Case Hardened Steel Fasteners

**Citation:** Medcalf, J.S., Thomas, B.G., and Brahimi, S.V., "Hydrogen Embrittlement Susceptibility of Case Hardened Steel Fasteners," SAE Technical Paper 2018-01-1240, 2018, doi:10.4271/2018-01-1240.

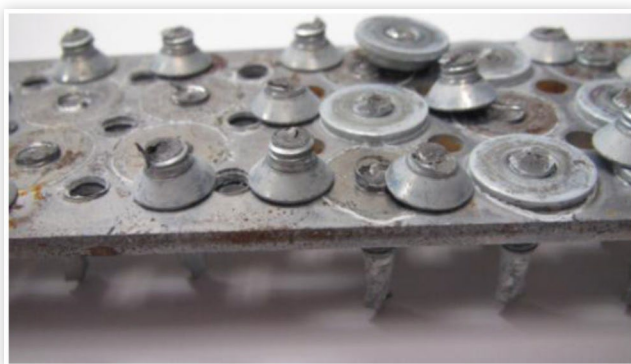
**FIGURE 2** Batch 19 after salt water embrittlement testing

The results of testing in a corrosive environment can be found in Table 2. Figure 2 shows the failures exhibited by Batch 19 tested in this fashion, which were typical of most failures observed. As shown in the Figure and results, 100 percent of the Batch 19 fasteners failed this testing in a corrosive environment, even though no failures were observed in the initial testing in air per ASME B18.6.3.

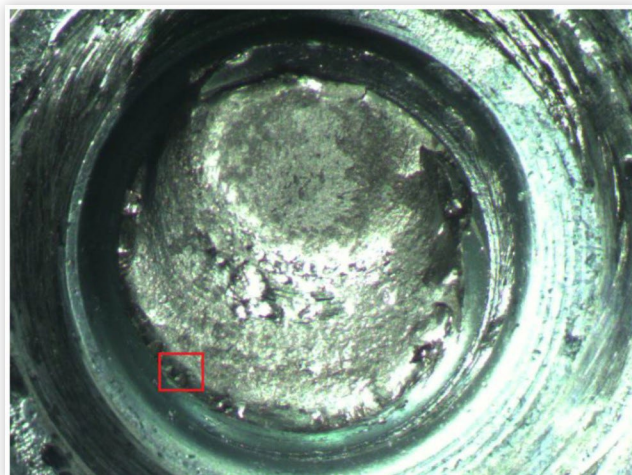
**FIGURE 11** Torsion failure fracture surface - area of note magnified in Figure 12

The first fracture surface examined by SEM was that of a fastener from batch 24 that was failed in torsion, represented

in Figures 11 and 12. The fracture surface mainly showed evidence of ductile failure, except for the high hardness surface region, which showed evidence of brittle intergranular fracture. This evidence can be seen circled in Figure 12.

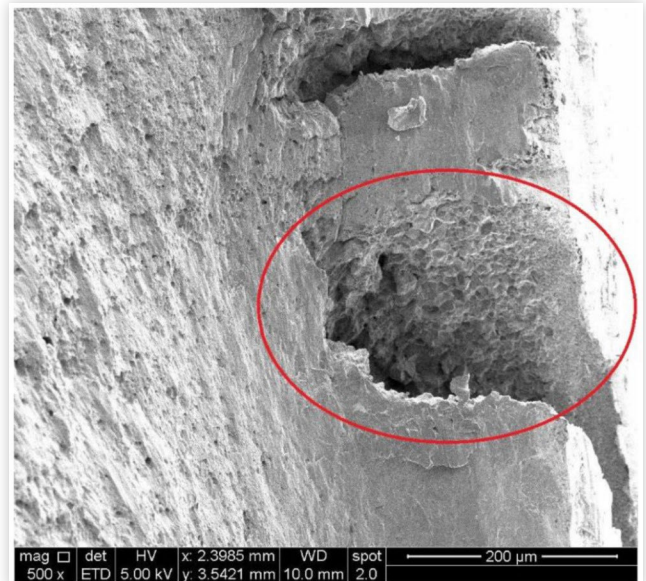
**FIGURE 12** Torsion failure fracture surface at case hardened area 500X magnification

Another feature observed during SEM analysis was the brittle intergranular fracture near the surface of a sample that was failed in torsion for establishing an assembly torque. Because it was not a delayed failure, the brittle fracture could not have been a result of hydrogen embrittlement. This feature is of interest, as during tightening the case hardened fasteners exhibited audible “popping” sounds as if they were beginning to crack well below the ultimate failure torque. If something in the nature of the high hardness outer case causes brittle cracks to form even during normal tightening, it may have the effect of increasing the susceptibility to EHE. This is another aspect that would be beneficial to evaluate further in future studies.

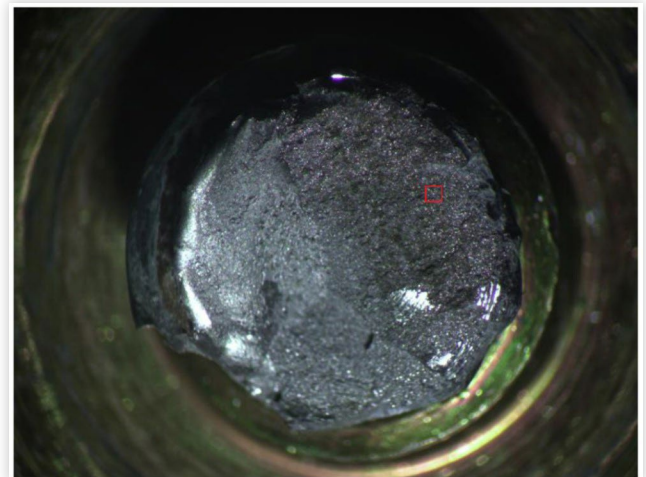
**FIGURE 13** Corrosive environment embrittlement failure fracture surface - area of note magnified in Figure 14

The next fastener examined was also from batch 24, but failed in sustained load embrittlement testing in a corrosive environment. Its fracture surface showed predominantly brittle intergranular fracture as seen in Figures 13 and 14. However, the lower hardness core also exhibited some ductile failure regions.

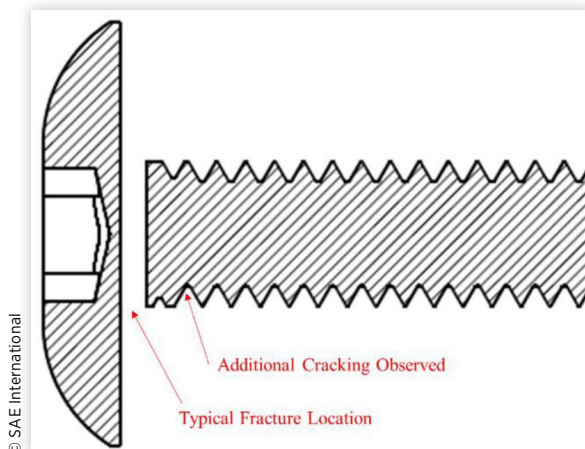
**FIGURE 15** Schematic of batch 30 sample that failed embrittlement testing showing location of additional cracking

Next, a sample from Batch 30 that failed in corrosive environment embrittlement testing was studied further under SEM, because a crack of significant length was observed during microhardness testing. Figure 15 shows the location of typical failures as well as the additional crack observed. Although this was not the crack that caused the fastener to fail the embrittlement test, it may have contributed to significant loss of strength. As seen in Figure 16, it extends from what appears to be a “lap” in the material caused by the thread rolling process.

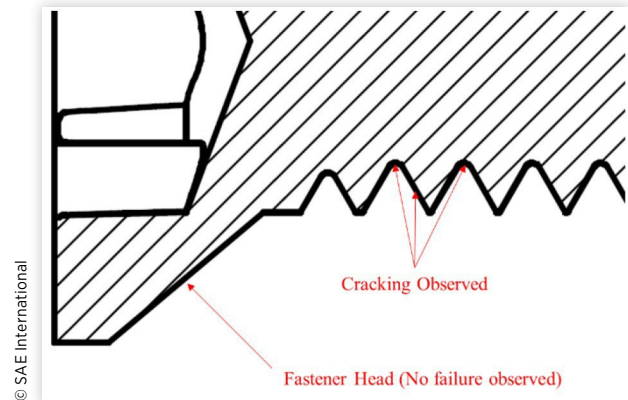
**FIGURE 17** Schematic of batch 17 sample that passed embrittlement testing showing locations of cracks observed

More unexpected features were the cracks observed in a sample from Batch 17 that did not fail embrittlement testing. Figures 17 through 20 show multiple cracks extending a significant depth into the fastener core and a crack on the flank of a thread, which would not have been expected to be an area of highest stress concentration. In all cases, the cracks appear to be brittle intergranular in nature, progressing from the high hardness surface and ending in the lower hardness core.

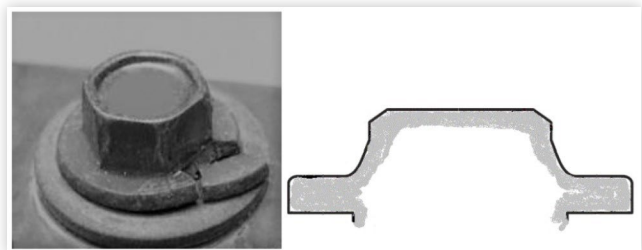
**FIGURE 22** Failure in hex washer head of batch 14 sample (left) and representation of case hardened layer (grey areas, right)

The outlying data point (plotted as an “X”) in Figure 3 corresponds with the upper right-most data series plotted in Figure 8. This is a sample with a hex-washer head that failed through the thin washer section of the head, as seen in Figure 22, even though the fastener shaft did not fail or exhibit signs of cracking. This is another significant result in that it points to the geometry dependence of the susceptibility of case hardened fasteners to hydrogen embrittlement. If a case hardened fastener has locations of lower net section area, a larger percentage of the material is affected by the case hardening treatment. This

is also depicted visually in [Figure 22](#) and seen in [Figure 8](#), where the hardness measured across the thin washer sections of two fasteners remained elevated nearly 30 percent of the distance into the section, as opposed to less than 20 percent in any of the threaded sections studied. In addition, if the fastener head is not parallel to the bearing surface, bending during installation can increase the applied stress. This would appear to be the primary influence of case depth on material susceptibility, as [Figure 5](#) otherwise shows no correlation between failure rate and normalized case depth. Instead, geometry appears to be more influential than depth itself. However, it should also be noted that all samples tested had case depths conforming to specifications. Case depth exceeding specified values may greatly increase susceptibility to hydrogen embrittlement.
