2018-01-1240 Published 03 Apr 2018

# Hydrogen Embrittlement Susceptibility of Case Hardened Steel Fasteners

John S. Medcalf Peak Innovations Engineering

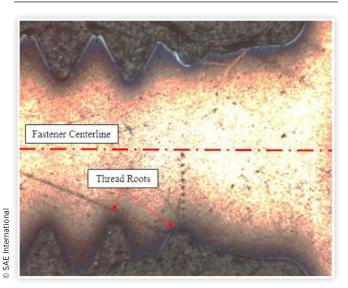
The next phase of this study measured hardness profiles of the fasteners, in order to evaluate how far into the net section of the fastener the elevated surface hardness had some effect. Thus, several fasteners from each batch that underwent environmental embrittlement treatment and testing were measured. In lots that did not either pass or fail 100 percent, samples of both passing and failing fasteners were tested. The sample fasteners were sectioned longitudinally, mounted in phenolic resin, and polished for microhardness measurements. Attention was focused on the underhead fillets and thread roots of the fasteners where stress concentrations are highest. Starting at a thread root on each sample, Vickers hardness readings were taken at a distance of 0.002 inches from the surface, and every 0.003 inches travelling away from the surface towards the centerline, until the hardness gradient leveled off, with a final reading taken near the center of the fastener. An example of a typical hardness reading traverse is pictured in Figure 1.

addition to measuring hardness, the visual characteristics of the microstructures achieved during the case hardening process were also investigated. Beyond hardness, it was desired to examine the samples to evaluate if any significant differences in microstructure could be observed between fasteners that did or did not fail the environmental embrittlement testing. In order to capture a range of conditions, samples were chosen with high and low hardness, as well as samples that passed and failed the embrittlement testing. The fasteners **FIGURE 1** Typical microhardness reading locations (100X magnification)
