# Hydrogen Embrittlement Susceptibility of Case Hardened Steel Fasteners

**Citation:** Medcalf, J.S., Thomas, B.G., and Brahimi, S.V., "Hydrogen Embrittlement Susceptibility of Case Hardened Steel Fasteners," SAE Technical Paper 2018-01-1240, 2018, doi:10.4271/2018-01-1240.

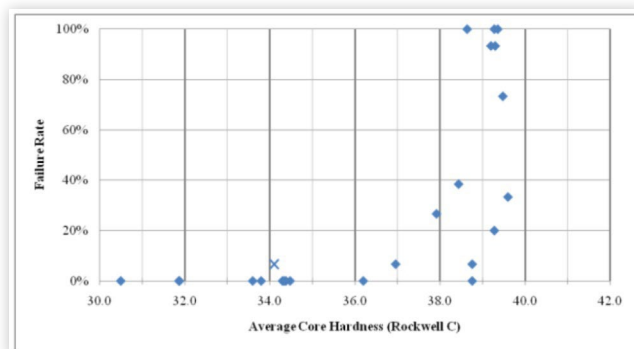
**FIGURE 3** Plot of failure rate versus nominal core hardness

With failures observed, the results were plotted against case hardening variables in order to observe trends. Figure 3 shows the failure rate as a function of the average core hardness

as reported by the heat treatment facility. It is important to note that the average core hardness represents a snapshot of the overall hardness of the lot, but not necessarily of the specific samples that failed. Due to the variation in hardness from sample to sample, the actual hardness varies by several (two to three) points on the Rockwell C scale. Figure 4 plots the failure rate versus the average case hardness as reported by the heat treatment facility, with the same considerations as mentioned for the core hardness.

The outlying data point (plotted as an “X”) in Figure 3 corresponds with the upper right-most data series plotted in Figure 8. This is a sample with a hex-washer head that failed through the thin washer section of the head, as seen in Figure 22, even though the fastener shaft did not fail or exhibit signs of cracking. This is another significant result in that it points to the geometry dependence of the susceptibility of case hardened fasteners to hydrogen embrittlement. If a case hardened fastener has locations of lower net section area, a larger percentage of the material is affected by the case hardening treatment. This

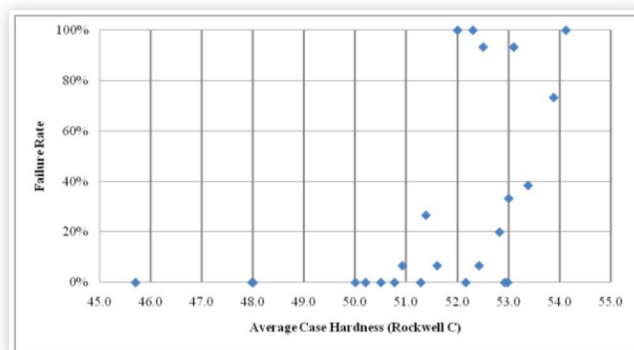
**FIGURE 4** Plot of failure rate versus nominal case hardness

When considering the effects of case hardness, [Figure 4](#) shows a similar correlation of increasing failure rate with increasing hardness as [Figure 3](#). However, the relationship is less distinct than the trend with core hardness. Multiple batches with a case hardness near HRC 53 exhibited a zero percent failure rate, while multiple batches with a case hardness near HRC 52 exhibited a 100 percent failure rate. What does emerge though is a drastic reduction in failures as the case hardness drops below HRC 51. However, this is where the relationship between case hardness and core hardness should be examined. [Figure 23](#) first plots both the nominal case and nominal core hardness for 24 lots in order of increasing core hardness. [Figure 24](#) then plots the average case hardness as a function of the average core hardness, with a trend line plotted for reference. Both figures indicate that while it is not a direct correlation, in general when the core hardness increases, the case hardness will increase as

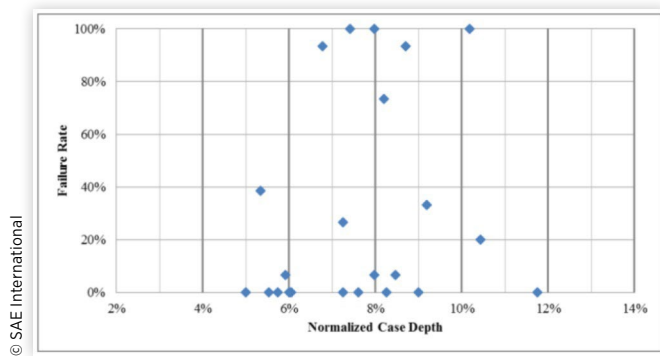
**FIGURE 5** Plot of failure rate versus normalized case depth

Case depth is the first parameter that is affected by the geometry of the fastener. Clearly a case depth of 0.008 inches, for example, would have a much greater effect on a small diameter fastener than a large diameter fastener. For this reason, the average case depths measured by the heat treatment facility were normalized to create one relative scale. To normalize the values, the case depth was divided by the fastener radius at the thread roots. This value was then expressed as a percentage. Figure 5 plots the failure rate versus the normalized case depth.

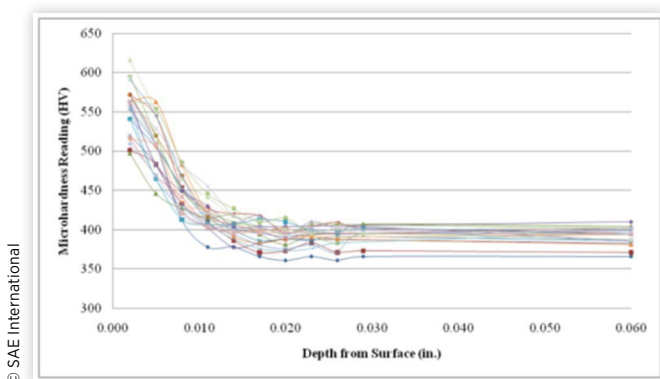
**FIGURE 7** Microhardness profiles of samples that failed embrittlement testing

failed embrittlement testing are shown in Table 4. The “CORE” location indicates a reading taken near the center of the net fastener section. Figures 6 and 7 plot the hardness measurements of un-failed and failed samples respectively versus the distance from the surface. The “core” measurement was given a depth of 0.060 inches for the purposes of plotting.

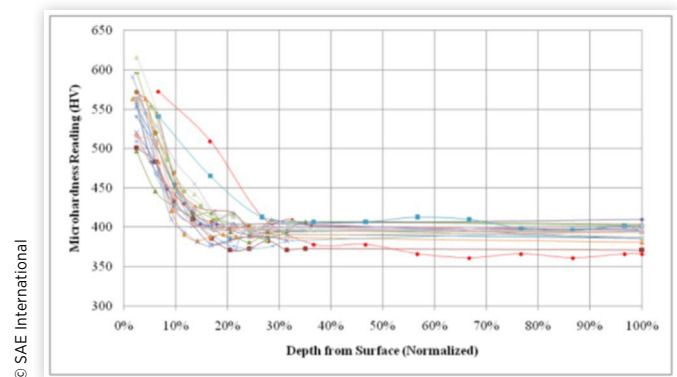
**FIGURE 8** Normalized microhardness profiles of samples that failed embrittlement testing

Once again, because depth of hardness is expected to affect fasteners differently based on geometry, the data were normalized for further analysis. Figure 8 plots hardness versus a normalized depth for samples that failed embrittlement testing. The normalized depth is calculated by dividing the actual

distance from the surface by the fastener radius at the nominal minor diameter. In the case of the two samples measured across the washer feature, it is the actual distance divided by the net section width of the washer. These two samples stand out, as their thin section width causes a higher percentage of the cross-section area to be affected by the increased surface hardness.

is also depicted visually in [Figure 22](#) and seen in [Figure 8](#), where the hardness measured across the thin washer sections of two fasteners remained elevated nearly 30 percent of the distance into the section, as opposed to less than 20 percent in any of the threaded sections studied. In addition, if the fastener head is not parallel to the bearing surface, bending during installation can increase the applied stress. This would appear to be the primary influence of case depth on material susceptibility, as [Figure 5](#) otherwise shows no correlation between failure rate and normalized case depth. Instead, geometry appears to be more influential than depth itself. However, it should also be noted that all samples tested had case depths conforming to specifications. Case depth exceeding specified values may greatly increase susceptibility to hydrogen embrittlement.

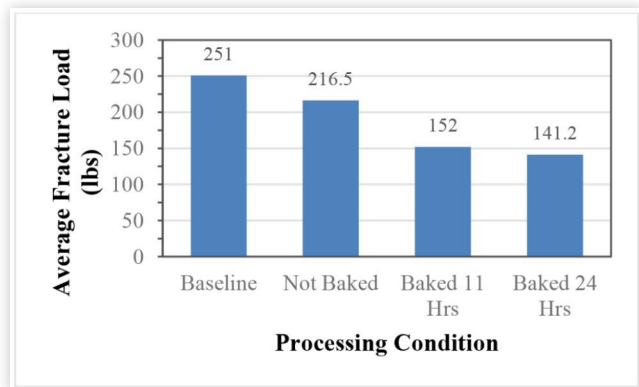
**FIGURE 21** Results of ISL testing of notched bars

The average fracture loads measured during ISL testing of the bars are shown in Figure 21. Per the ASTM F1940 standard, if the fracture load of the plated bars exceeds 75 percent of the baseline value, the process is not considered embrittling. The sample not baked as part of the electroplating process fractured at a load that would not indicate it had been embrittled. However, both samples baked at 200°C fractured at values below 75 percent of the baseline value. This indicates that the inclusion of these baking processes actually contributed to embrittlement, rather than preventing it.

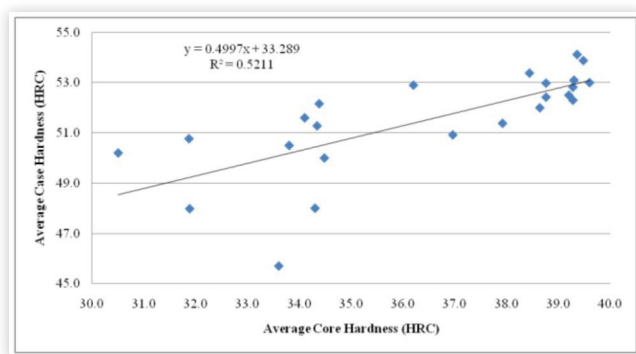
**FIGURE 24** Relationship between case and core hardness

Because the two values are related, it is desirable to consider which value is more influential in the susceptibility of fasteners to hydrogen embrittlement failures. As noted, if the trend line plotted in [Figure 24](#) is used to estimate core hardness, the case hardness threshold leads to a very conservative calculated core hardness threshold. However, when the observed core hardness threshold of approximately HRC 36.5 is used to calculate the case hardness, an accurate value of HRC 51.5 is obtained. This suggests that core hardness is the more significant indicator of susceptibility (and not case hardness). This finding would also appear to be supported by features observed during microscopic analysis. [Figure 16](#) shows a brittle intergranular crack extending over 0.008 inches into the core of a failed sample, even though this crack did not cause the failure. As this fastener exhibited high hardness throughout, it is reasonable to believe that if the stress had been higher in the core region, the crack would have continued to extend through the entire cross section. However, [Figures 18](#) through [20](#) show brittle intergranular cracks extending as far as 0.015 inches into the core of a sample from batch 17 that did not fail embrittlement testing. When compared with the microhardness readings, this is precisely the depth where hardness begins to drop to the HV 370 or HRC 37 range and below. These findings support the conclusion that the material condition at the surface of case hardened fasteners may always be susceptible to hydrogen assisted brittle intergranular cracking, but it is the condition of the core or bulk of the material that will ultimately determine if the fastener fails. Even if cracks begin in the high hardness surface, if the core is at a low enough hardness the crack will stop when it reaches the more ductile material. The fact that the threshold for core hardness is lower than that of through hardened fasteners exhibits the influence of case hardening in that it appears to create a condition much more likely to initiate cracks and allow them to grow a certain amount through the section. As the cracks grow, the net section area of the fastener is reduced, and the stress at the crack tip would be expected to rise. As stress increases, the material condition and hydrogen content thresholds required to propagate the crack would be reduced. Thus, case hardened fasteners create a much more susceptible condition than through hardened fasteners, with core hardness being the primary consideration on whether they are susceptible to failure.

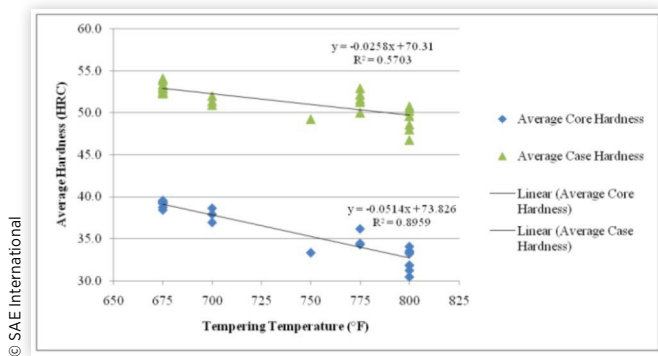
**FIGURE 25** Effect of tempering temperature on hardness

If it is then determined that limiting core hardness below HRC 37 is the desirable end result of heat treatment, the method of ensuring this condition should be known. Fastener steel grade and property class standards such as SAE J429 and ISO 898-1 require a minimum tempering temperature to ensure proper material conditions [15, 16]. [Figure 25](#) plots the

reported average case and core hardness as a function of tempering temperature. SAE J78 on self drilling screws requires a minimum tempering temperature of 625°F, but from the fasteners in this study it would appear that a tempering temperature somewhere above 700°F would be required to ensure a core hardness below HRC 37. However, the effect of these temperatures on the ability to meet the minimum case hardness of HRC 50 for self drilling screws is unclear. As it was not the primary goal of this study, the effect of tempering temperature on material properties and hardness for various case hardening materials would need to be further investigated. However, the linear regressions plotted in Figure 25 reveal that core hardness is more affected by tempering temperature than is case hardness. From the viewpoint of processing to control hydrogen embrittlement susceptibility this is fortunate, as core hardness appears to be the primary variable to control. Additional investigations on the effect of tempering temperature on hydrogen embrittlement of fasteners should also consider and take care to avoid the possibility of the different but related problem of temper embrittlement.
